915 Repair Tutorial – Part III

By: Peter M. Zimmermann

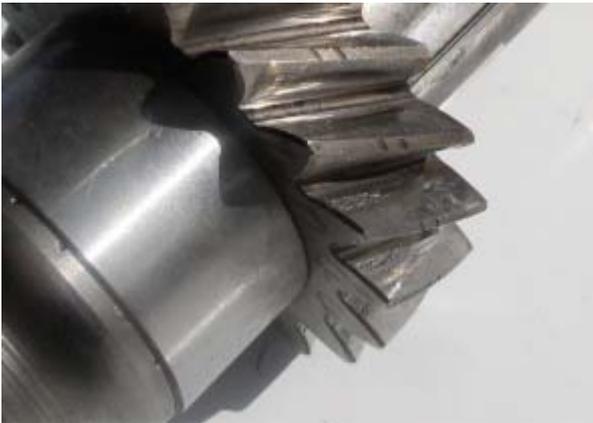
Look carefully at the teeth; you will see wear through of the hardened surface of the teeth. Unfortunately this has become typical of late, especially on 1st and 2nd gears, but we don't have that problem on our subject.

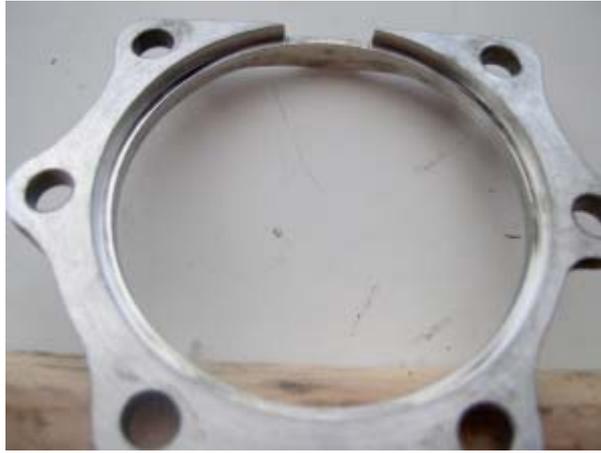
The plates are designed to control radial and axial play, but only to a point. They cannot prevent bearing race opening (hole) failure. As you can see, the clamping plate has a machined recess that pushes against the flange of the 043 00 bearing, forcing it against the pinion depth shims and the 146 00 bearing. I could not guess at the original intent of the engineers regarding the clamping plates, because they also had to consider the axial and radial play of the bearings as well. The best explanation that I can come up with is that the pressure against the 146 00 bearing is not intended as a failure guard, but is the result of the design. After the bearing race starts to spin in the housing, it also begins to develop a small amount of axial play, which allows the 043 00 bearing to move inside the clamping plate, which seems to cause the wear at the plate's pressure point. That pressure point is thin, approximately 2.5mm, and when its wear reaches the point where the plate should not be reused, it will have a trough-like appearance.

I'm not aware of a wear limit spec for the depth of the plate (shim surface to bearing contact surface), but a plate in usable condition should probably not measure more than 4.25mm. A visual inspection will reveal the wear/condition, and what is certain is that the forces generated in that part of the transmission exceed that of the designed limits. The clamping plates seem to be the forgotten part in the 915, almost as though the factory did not think wear to them was possible.

If the clamping plate requires replacement that's when this gets tricky, because the pinion shaft plate is currently "NLA." The three letters that send shivers up the spines of many P-car enthusiasts; NLA = No Longer Available. This leaves us two choices; (1) locate "new old stock" where the part is still available in a wholesaler/retailer's inventory, or (2) purchase and use an aftermarket substitute. At this writing I've been successful with finding a factory replacement when needed, so, because I've never used an aftermarket alternative, I can't report on those items.

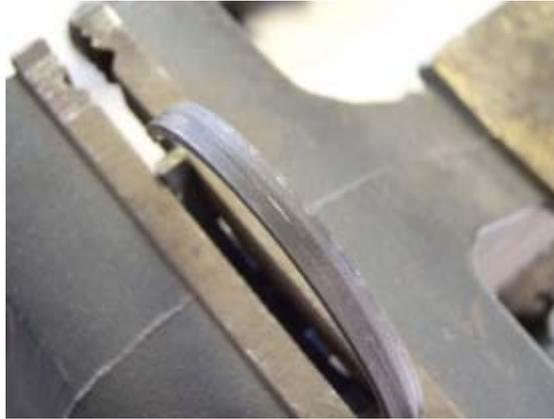
NOTE: I can't possibly cover every failure scenario in this tutorial, so we're going to do the basics on our subject. Before we take 2nd gear apart there are some things to know. The synchro ring has a sprayed-on coating that provides an incredibly durable, hard, friction surface. However, that surface does wear away over tens of thousands of miles, to the point where the synchro ring becomes smooth, even shiny, in places. Shiny means replace.

This project is starting to sound expensive, and we've just scratched the surface. We now know that we're going to replace the 2nd gear synchro, the 1st gear synchro, and the 1/2 slider. You will read stories about how it's OK to "flip" the synchro and re-use it (a procedure some do by taking a worn synchro and "flipping" it over so that the unused side faces the slider). This strategy might be viable in a racing transmission that's little more than a high-rev crash box, but for a transmission intended for use in a nice street machine it's absolutely unacceptable. Shifting quality will always be compromised because of how the synchromesh works.

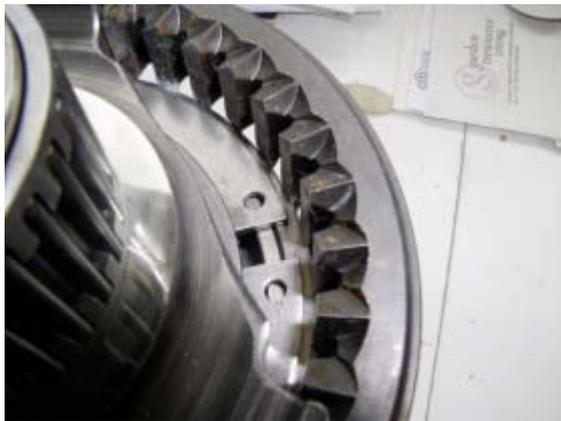
When a synchro ring wears away, the part that does the machining is the sliding sleeve, or slider...

The two parts wear together, and because a wear pattern forms on the teeth of the slider, it must be replaced with its synchro rings.

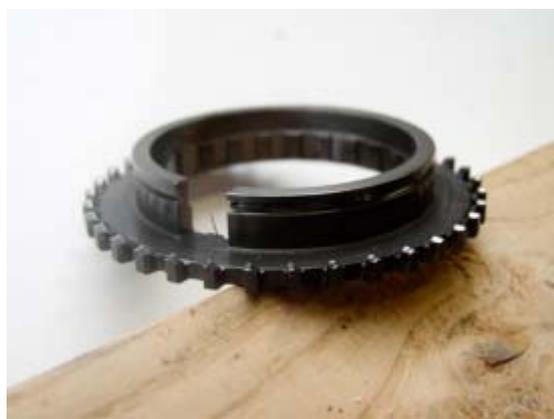
The dog tooth ring...

...has a precision inside diameter, and the synchro ring presses into the dog teeth. The pictured ring has heavy wear to its teeth...

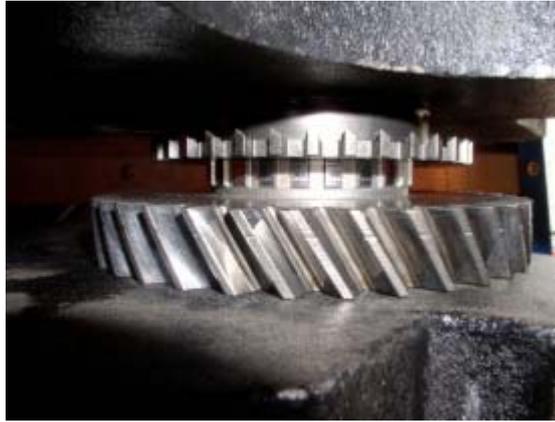
...compared with the teeth on a new dog ring (look carefully at the tips/points of the teeth). It is not unusual to find broken dog teeth, their small parts will eventually end up stuck on the drain plug magnet.

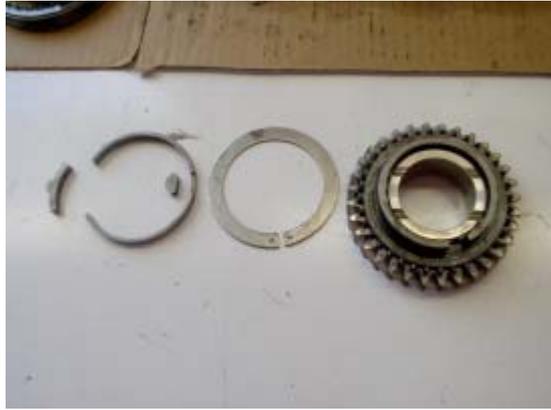
NOTE: 2nd gear synchro components are; (1) anchor block (smallest part in above picture), (2) energizer block, (3) brake band, (4) retainer, and synchro ring (not shown).

Everything on our subject is in good condition, except for the synchro ring, and can be re-used. If your transmission has had a traumatic failure, you might (usually) find broken dog teeth, disfigured brake bands and blocks, in addition to other forms of damage. Although our subject's dog teeth look very good, we'll check them with a new synchro ring.

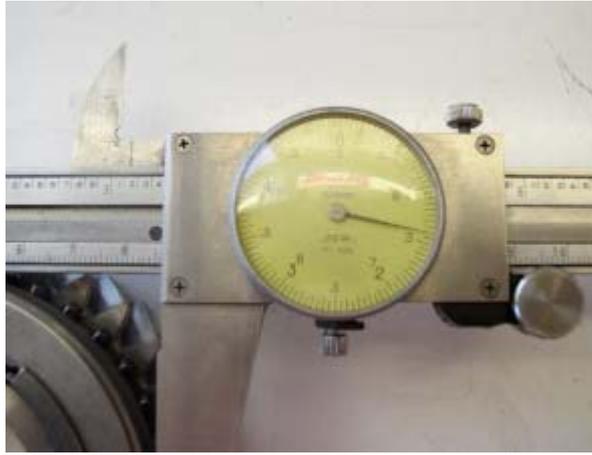
Measure the synchro ring in at least three places, it will be slightly smaller near the opening, but that's normal. If the ring measures outside the tolerance range, on the large side, the dog teeth will have to be replaced.
