915 Repair Tutorial – Part III

By: Peter M. Zimmermann

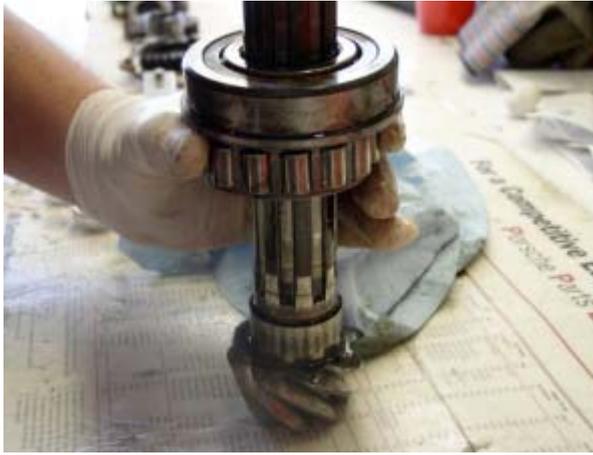
Clean the entire pinion shaft and examine the teeth of the pinion head; all of them, on both sides. No pock-marks in the smooth finish of the teeth are permissible for re-use. In other words, any wear that is through the hardened surface means that you are holding a thousand dollar piece of junk; or a paper weight that will be sure to be an unusual conversation starter at the office. Pictured below is a gear with wear-through that can, but rarely shows up on, a pinion gear (which is why I don't have a failed ring & pinion to photograph for you).

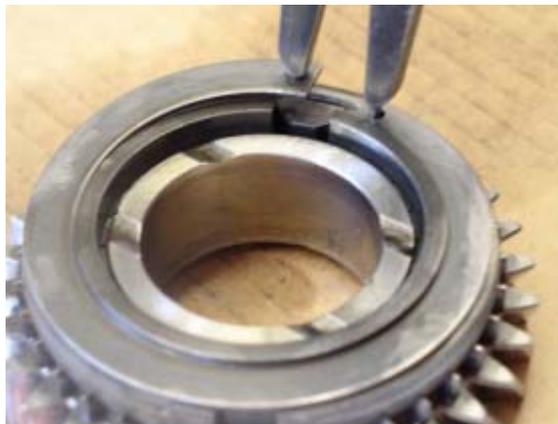
Pick up your snap ring pliers and remove the synchro retainer. It will be tight, be sure that the tips of your pliers are well-seated in the retainer's holes, and hold your opposite hand so that if the pliers come loose under pressure they won't hit your hand. Trust me, this can hurt.

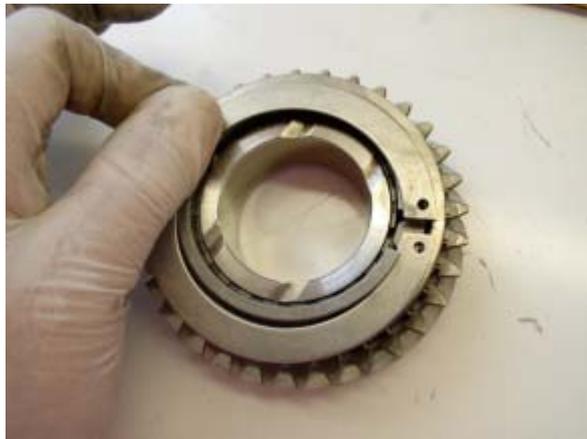
The installed dimension of the 1st or 2nd gear synchro ring is $86.37 \pm 0.17\text{mm}$ ($76.3 \pm 0.18\text{mm}$ for 3rd-5th). If you were to take a worn synchro ring and flip it, and re-install it into a worn dog tooth ring, it will be able to expand to a larger than acceptable dimension. Combine that with a slider whose teeth have a wear pattern that conforms to the worn out side of the synchro, and you create a difficult shifting condition that requires a higher than normal level of force to shift the car. While those difficult shifts are made a second problem, one that affects longevity, occurs. The friction material on the "good" side of the synchro is carved away by the unmatched, used, slider, which can greatly reduce the synchro's useful life. That friction material will then fly around the inside of the transmission, finding its way into bearings and around other parts. Not a pretty picture. Basically, flipping a synchro might sound good, but in reality has no upside.

Measure the synchro ring in at least three places, it will be slightly smaller near the opening, but that's normal. If the ring measures outside the tolerance range, on the large side, the dog teeth will have to be replaced.
