The Porsche Type-915 Transmission - Part IX

As the 915 moved through its fifteen years of production, engine displacement, horsepower and torque all increased, which made internal modifications to the 915 necessary. I'll discuss some of those changes, as well as relate some stories and technical help bits.

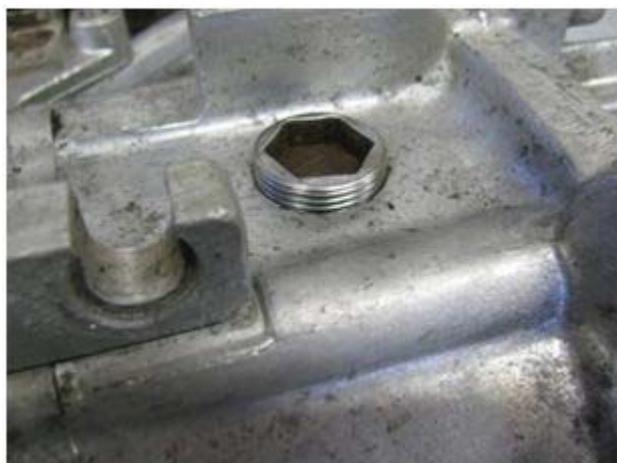
NOTE: Sometime during 915 production the design of the above plugs changed from a plug that was removed/installed using a 19mm wrench or socket, to a plug that required a 17mm hex wrench/socket.

The change was done, as close as I can pin-point it, at the end of 915/61 production. If ever in doubt, use 17 lb/ft as the torque spec, no matter if your transmission has a magnesium, or aluminum, housing, or if your plugs are the early or late type.

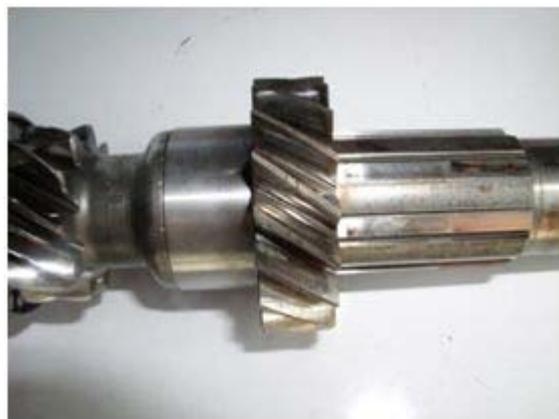
period. Not all factory manuals are complete with supplements, nor can Technical Specification books be changed, so it's possible that changes can be made, with only a tiny percent of the Porsche community aware of it. What I do, and the main shaft collared nut is a classic case, is go back in time until I find a design change that might correspond to a torque spec change. The design of the main shaft changed at one point, and the early versions placed the fixed gear of 2nd speed directly against a machined section of the main shaft. Later models incorporate a steel spacer between a redesigned surface and gear.

So, for many years, I've used the 166 lb/ft torque spec for all late main shafts, and use the high side of the early torque spec for early style main shafts.

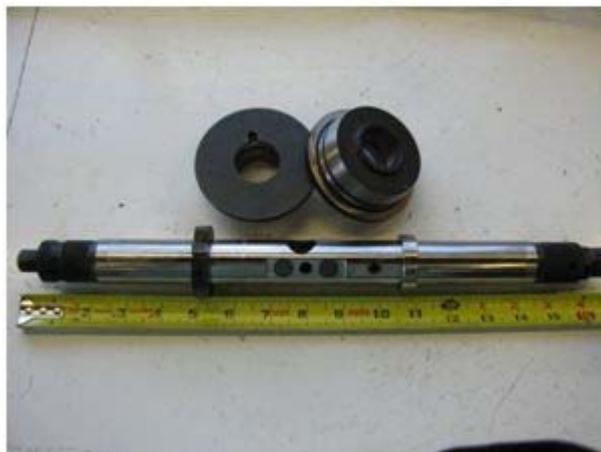
If you choose to shop for a 258 the tool should include bushings, a gauge block, and a dial indicator. If you find one for sale the seller can command a mighty price for it. A 385/1...

up until a few years ago, could be bought new for less than \$3,000, and, if you can locate one, should include a pair of pucks (bearing replacements)...

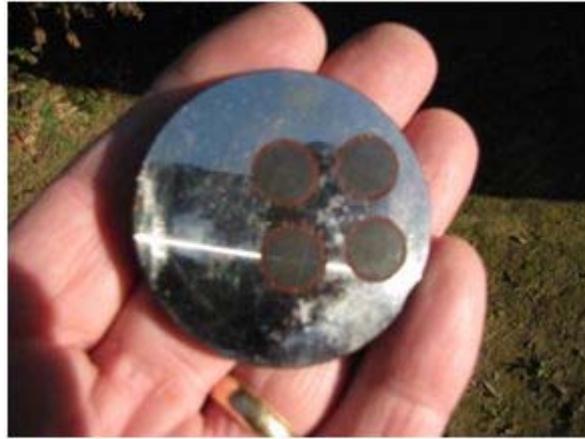
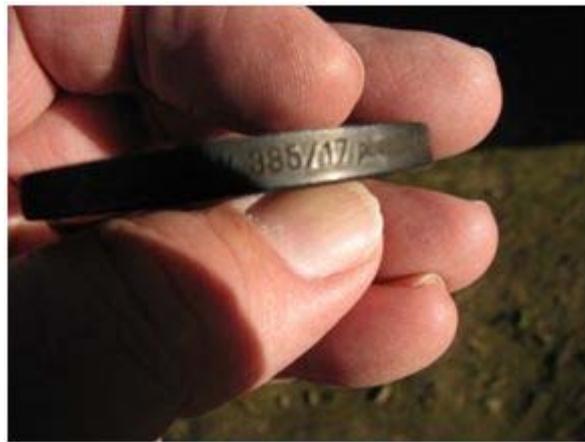
...a dial indicator and a magnetic pad...

that fits against the pinion head.

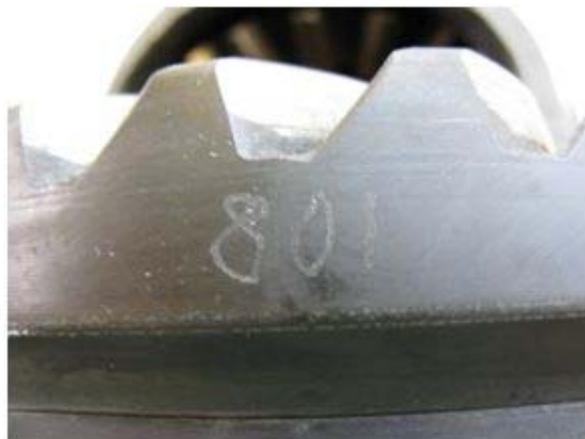
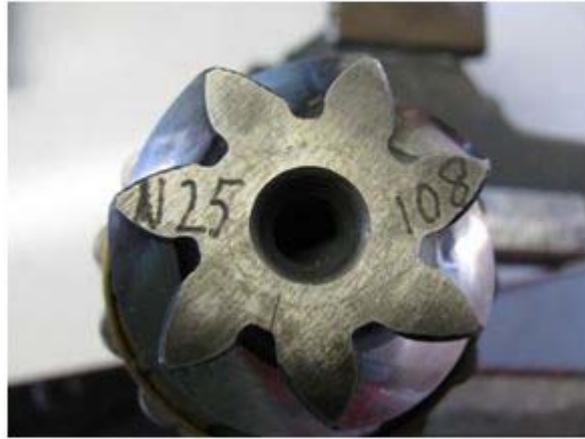
Every ring and pinion is inscribed with numbers. One each on the pinion head and ring gear will match, in this case "801", that's the pair number (example shown is a 914/4 ring & pinion).

The second number on the ring gear is the backlash specification...

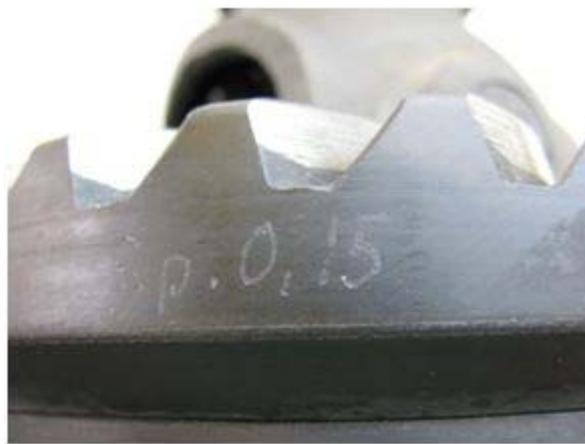
...and will read something like 0.15 (.15mm). The second number on the head of the pinion is referred to as the "N" number...

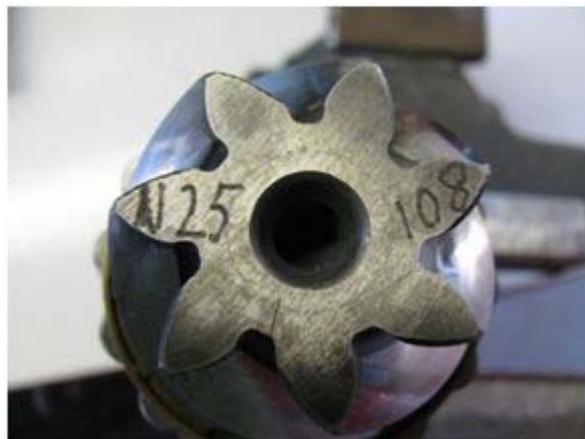
...that is actually the "r" number. "r" is the number that is the deviation (the distance deviating from design distance "R") that is measured by the factory. "R" is a set number, and is the distance between the center of the ring gear, and the inner edge of the ring gear's usable gear teeth. On 915s "R" = 66.30mm, and the gauge block (micrometer) is used to compress the contact plunger...

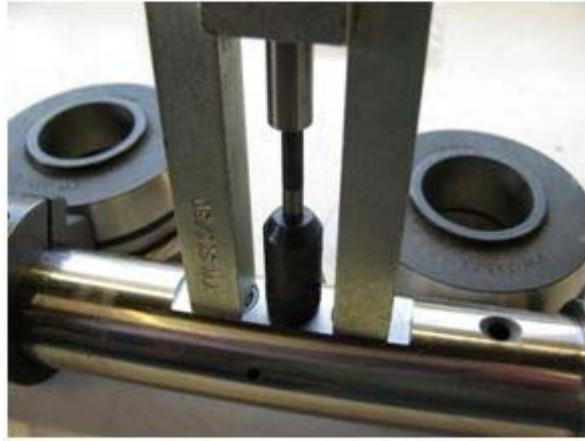
...so the installed dial indicator...

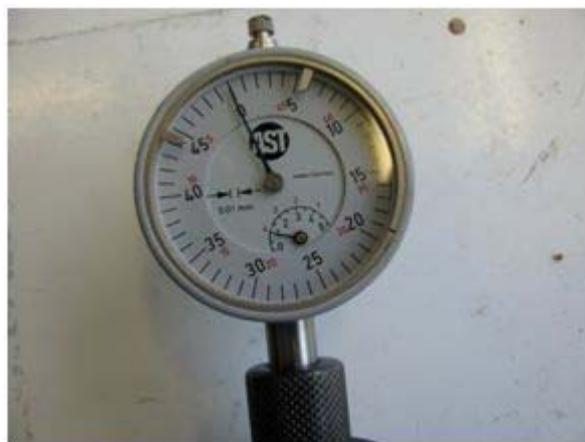
...may be set to 1mm pre-load so that the actual position of the pinion head, without shims, can be measured.

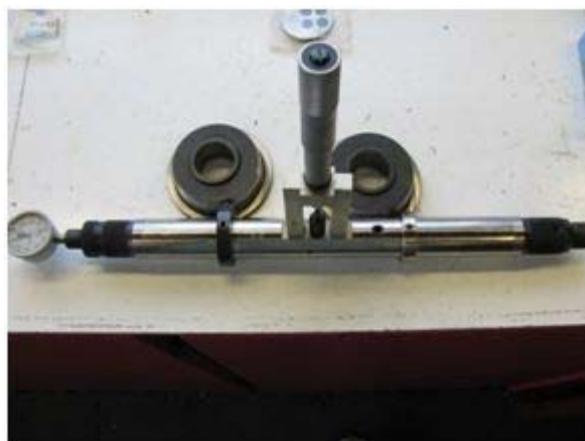
The assembled tool...

...may then be installed into the differential housing after good/new carrier bearing races are installed in the diff housing and side cover. The pinion shaft must be installed without shims, and its nut torqued to factory specification. Any axial play must be eliminated according to the process required by the tool that you have. At this point it's best to follow the step by step instructions in the factory manual to do the measurement and subsequent math to determine the new shim thickness needed to have the pinion head engage the ring gear at the precise depth.
